PAPERMILL POND DAM

CT. 00471

PHASE I INSPECTION REPORT
NATIONAL DAM INSPECTION PROGRAM

DECEMBER 1979

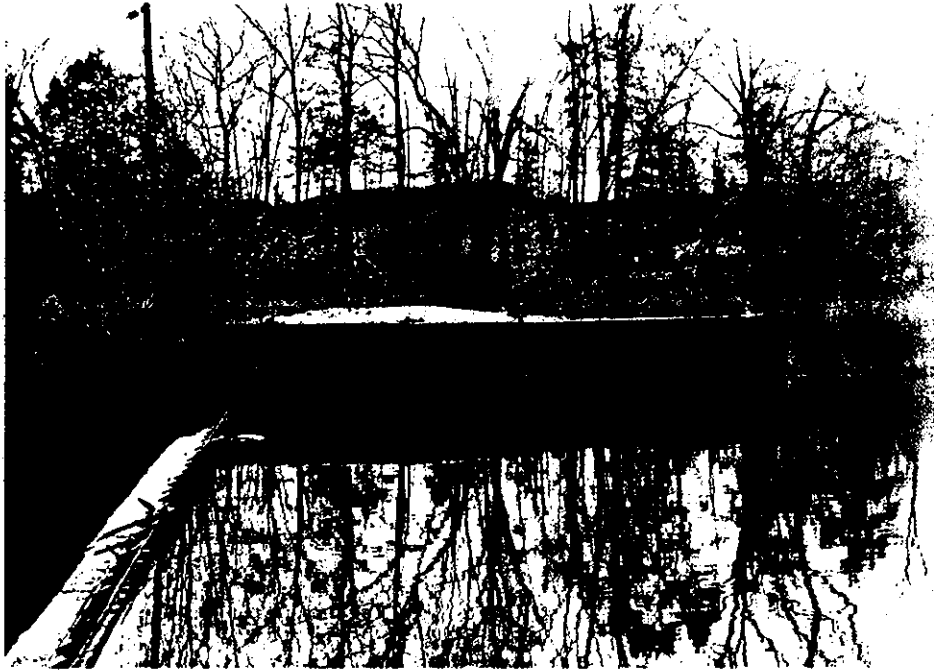
Overview of Dam from left spillway training wall.

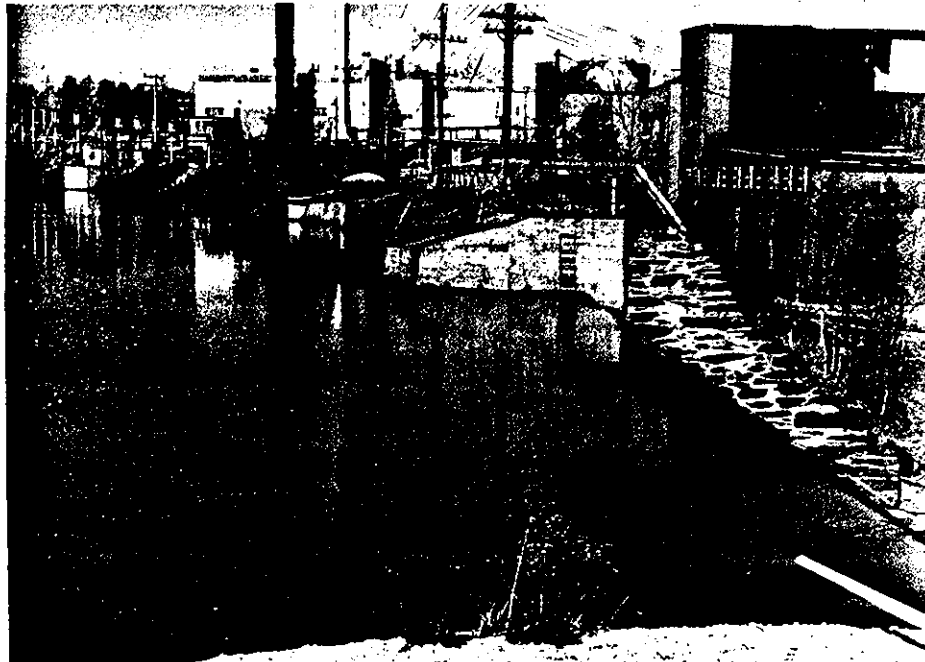
Overview of Dam from right spillway training wall.

The right embankment is of irregular shape and is about 18 ft. wide at its narrowest point. A vertical concrete wall extends along 60 ft. of the upstream face of the embankment and appeared to be in good condition. The right embankment is 0.8 ft. lower than the left embankment (see Overview Photo).

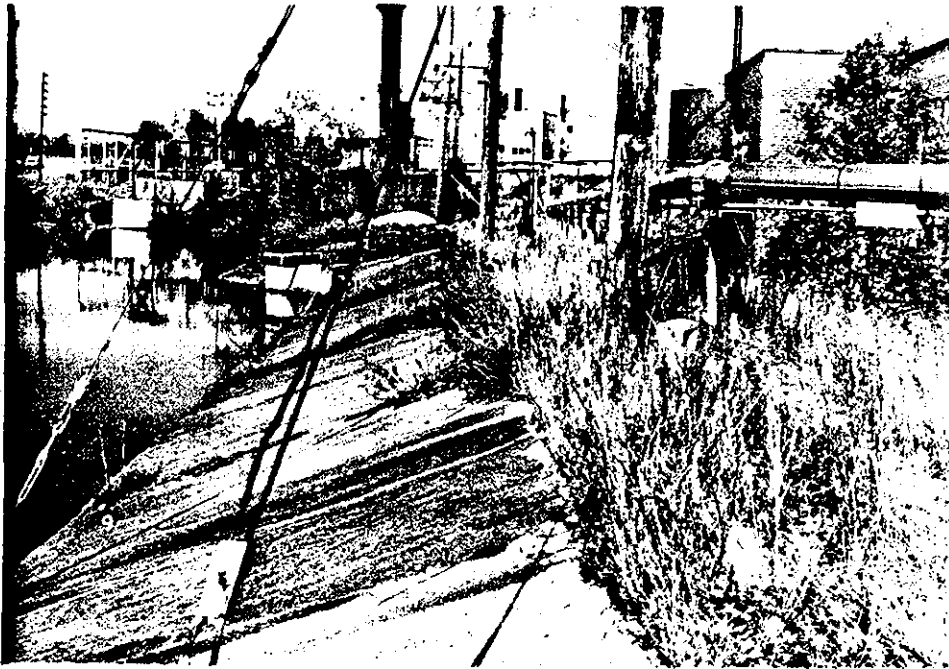
The left embankment is of uniform cross-section for a distance of about 160 ft. to the left of the spillway. It has a crest width of 12 ft. The downstream slope is about $1\frac{1}{2}$ horizontal to 1 vertical and the upstream slope is 2 horizontal to 1 vertical. The upstream slope is paved with concrete, which was added in 1959. Approximately 5 ft. from the left training wall of the spillway there was a transverse crack in the slab. There was also evidence of minor differential settlement (less than $\frac{1}{2}$ in.) which probably caused this crack. Construction joints, approximately 35 to 50 ft. apart, had opened laterally as much as $\frac{1}{2}$ in. Overall the slab was generally in good condition (see Photo Nos. 1 & 2 in Appendix C).

1. Upstream face and crest of left embankment

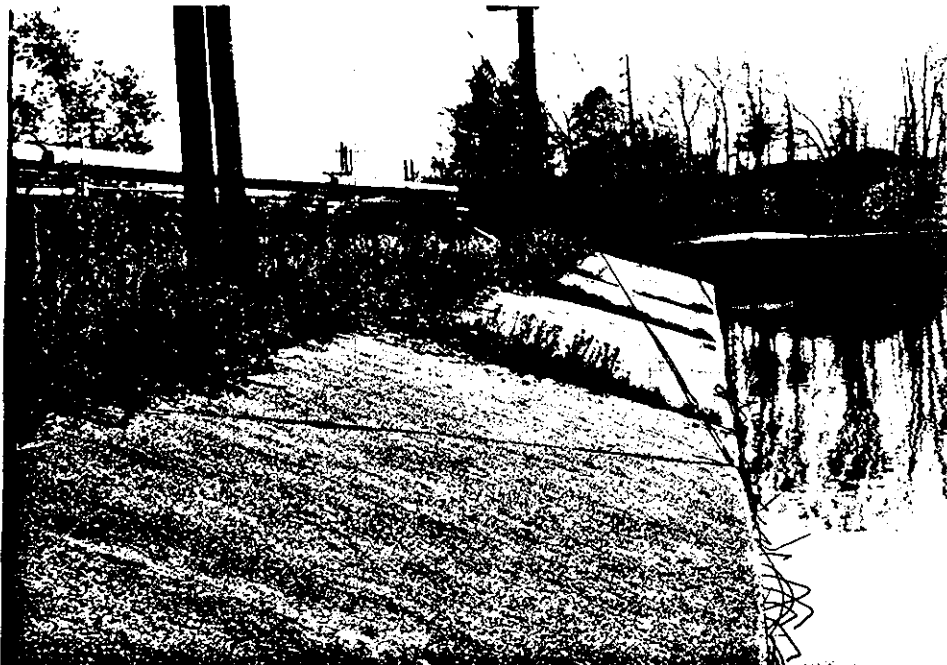
Crest Elevation	117.5 ft. (right embankment) 118.3 ft. (left embankment)
Current Pool Elevation	111.1
Maximum Impoundment to Date	Unknown
Surface Cracks	Transverse crack in concrete slab in left embankment, 5 ft. left of spillway.
Pavement Condition	None
Movement or Settlement of Crest	None
Lateral Movement	None
Vertical Aligment	Good
Horizontal Alignment	Good, but earth embankment left of turbine outlet is irregular
Condition at Abutment and at Concrete Structures	Good - concrete overlay missing on upstream side of left embankment
Indications of Movement of Structural Items on Slopes	None
Trespassing on Slopes	Minor
Sloughing or Erosion of Slopes or Abutments	Minor erosion on downstream side of left embankment near spillway training wall and left of turbine outlet.
Rock Slope Protection - Riprap Failures	None
Unusual Movement or Cracking at or near Toes	None
Unusual Embankment or Downstream Seepage	None

2. Concrete apron on upstream face of left embankment

- (1) Repoint mortar in the joints of the masonry rubble spillway face and spillway training walls.
- (2) Clean and repair the transverse crack in the concrete slab on the left embankment.
- (3) On the upstream face of the left embankment, clean and fill the construction joints in the concrete slab with a bitumastic joint filler.
- (4) Brush should be cleared from the embankments on both sides of the spillway on a regular annual basis.
- (5) Fill in erosion gullies on the downstream slope of the left embankment with suitable material, well compacted.
- (6) Monitor the turbine intake sluice gate for leakage and repair as necessary.
- (7) Develop a formal surveillance and flood warning plan, including round-the-clock monitoring during periods of heavy precipitation.
- (8) Institute procedures for an annual periodic technical inspection of the dam and its appurtenant structures.

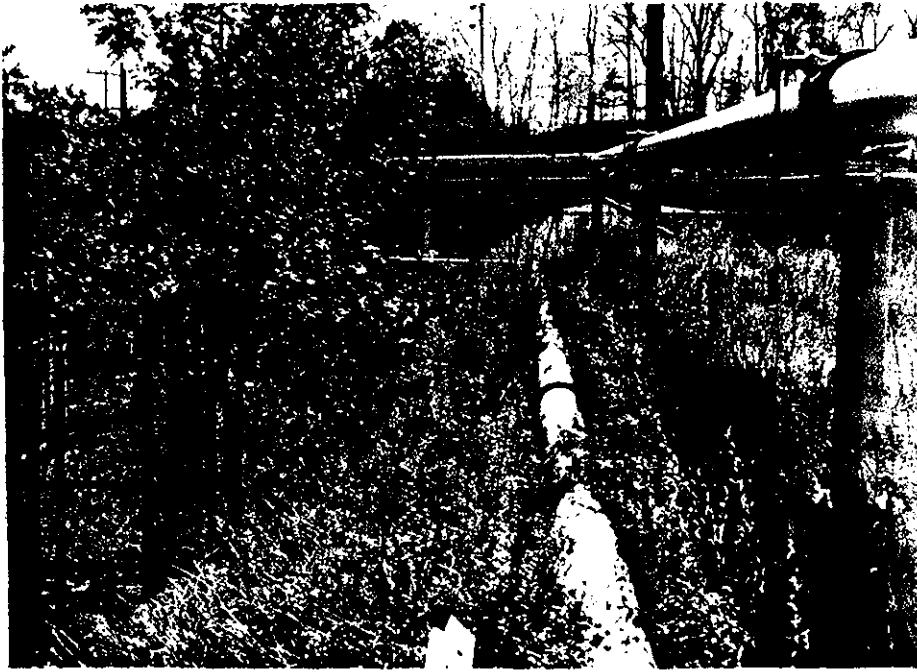
Minor brush growth had taken a firm stand along the crest and downstream slope of the embankment (see Photo No. 3, Appendix C). This growth could cause uplift of the slab if allowed to mature.

3. Brush growth on downstream slope of left embankment

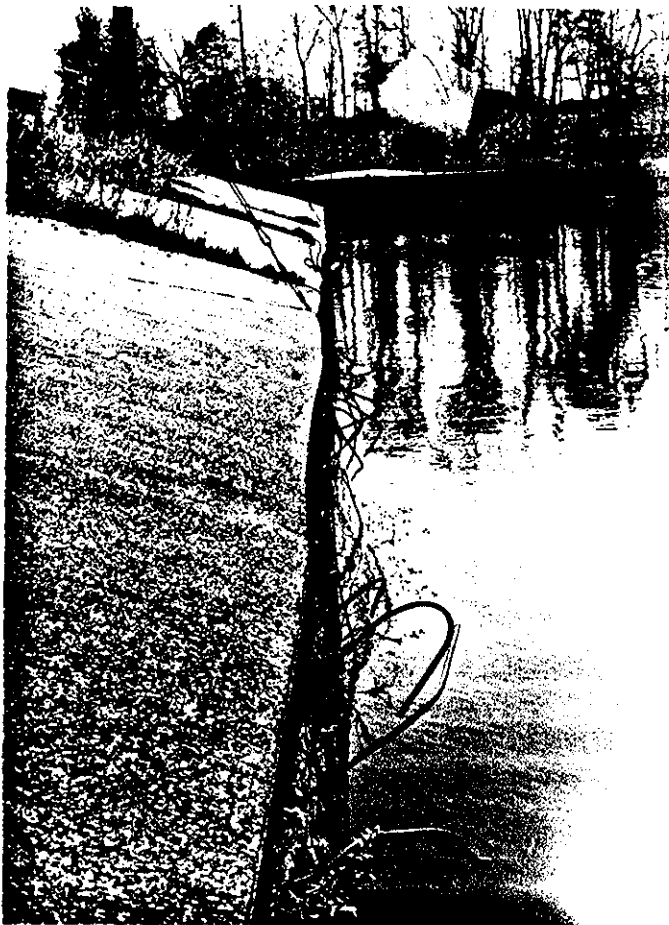
4. Reinforcing steel along upstream vertical rubble masonry face.

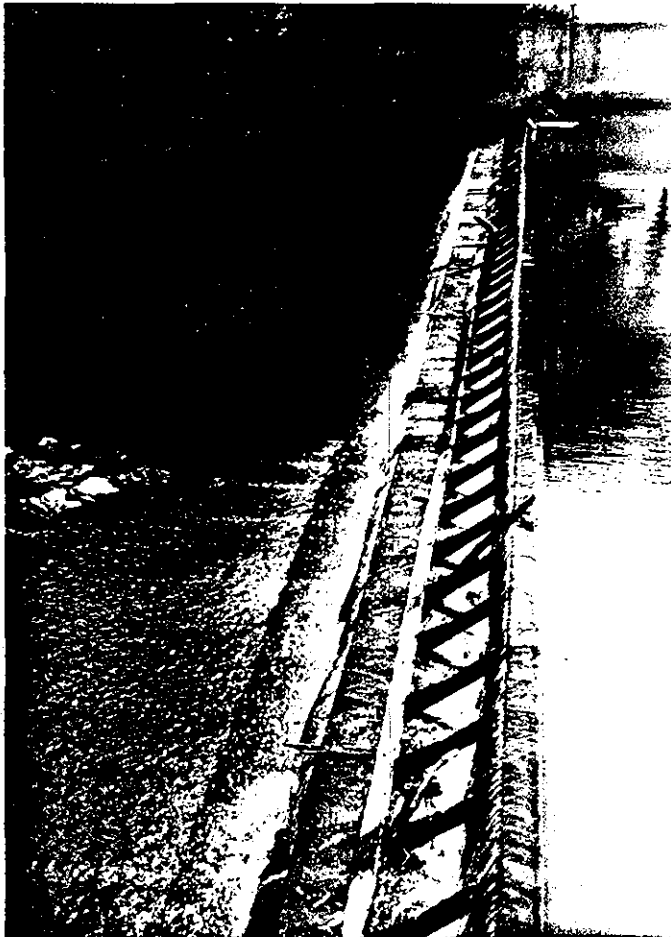
c. Appurtenant Structures. The overflow section or spillway of the dam is a rubble masonry gravity structure with mortared joints. There is a concrete cap about 1 ft. high across the crest. The downstream face of the spillway has a slight batter of about 12 vertical to 1 horizontal. The upstream face of the structure could not be seen as there was earth and silt up against it. Surmounted on the concrete cap of the spillway was a permanently installed wooden flashboard structure which is 2.3 ft. high. The upstream face of the structure had a stainless steel sheet face. The flashboards were mounted in a sloping position, at about a 60 degree angle from a downstream horizontal line. The spillway has rubble masonry downstream training walls and concrete training walls upstream of the crest. The spillway appeared to be in good condition, with the exception of some minor spalling of mortar from the joints of the rubble masonry downstream face, and localized areas of missing mortar in the joints of the training walls. In general, the concrete walls appeared to be in good condition with no cracks or distress noted (see Photo Nos. 6,7,8 & 9, Appendix C).

6. Spillway crest with flashboards.

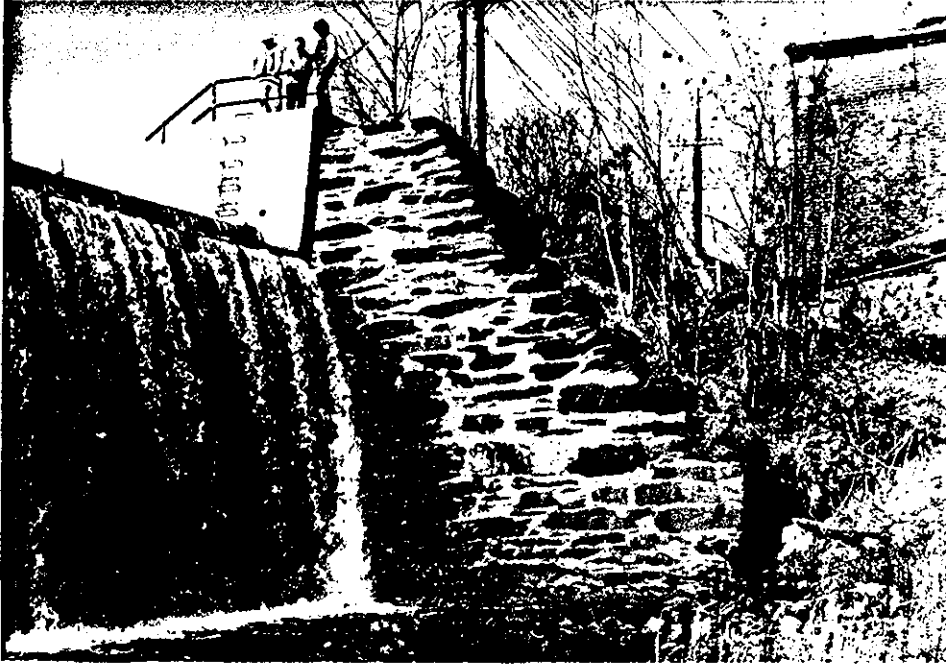
7. Left downstream rubble masonry training wall

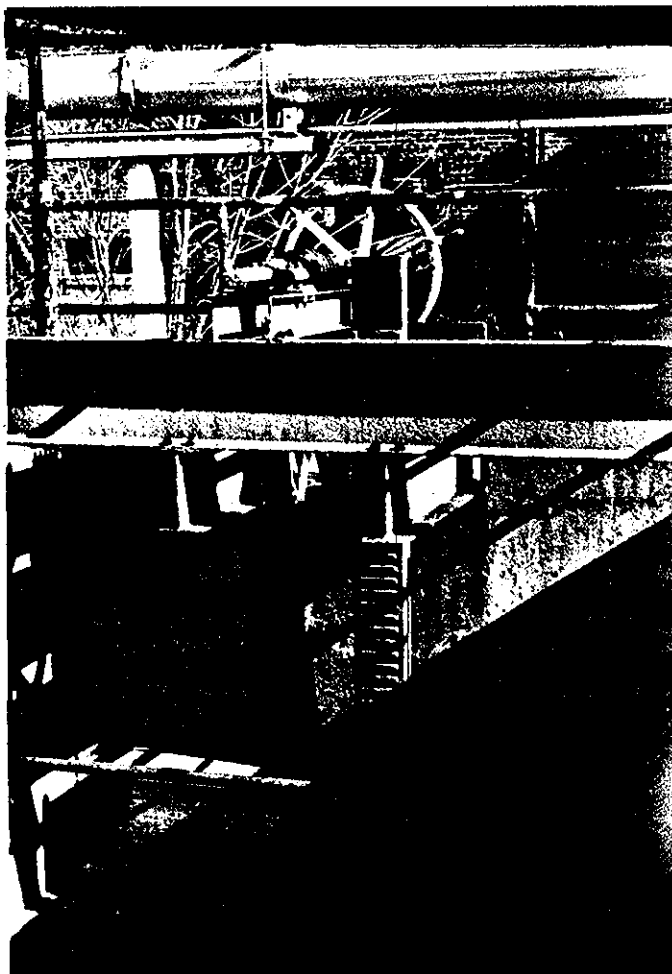
10. Rack and pinion sluice gate at inlet structure

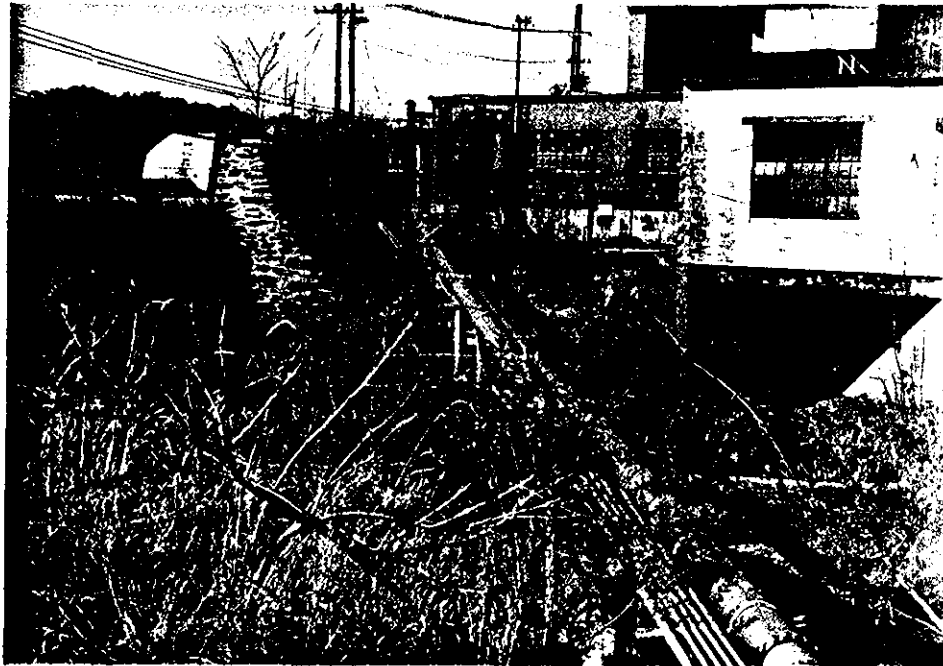
12. Tailrace outlet from abandoned turbine

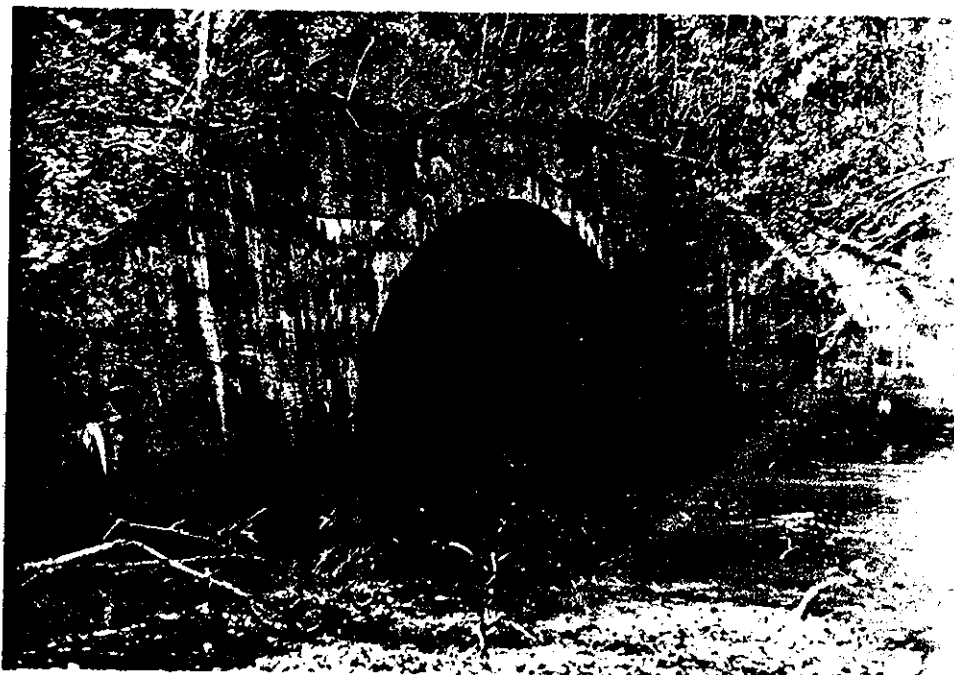
15. Masonry arch culvert carrying the Little River under the railroad embankment

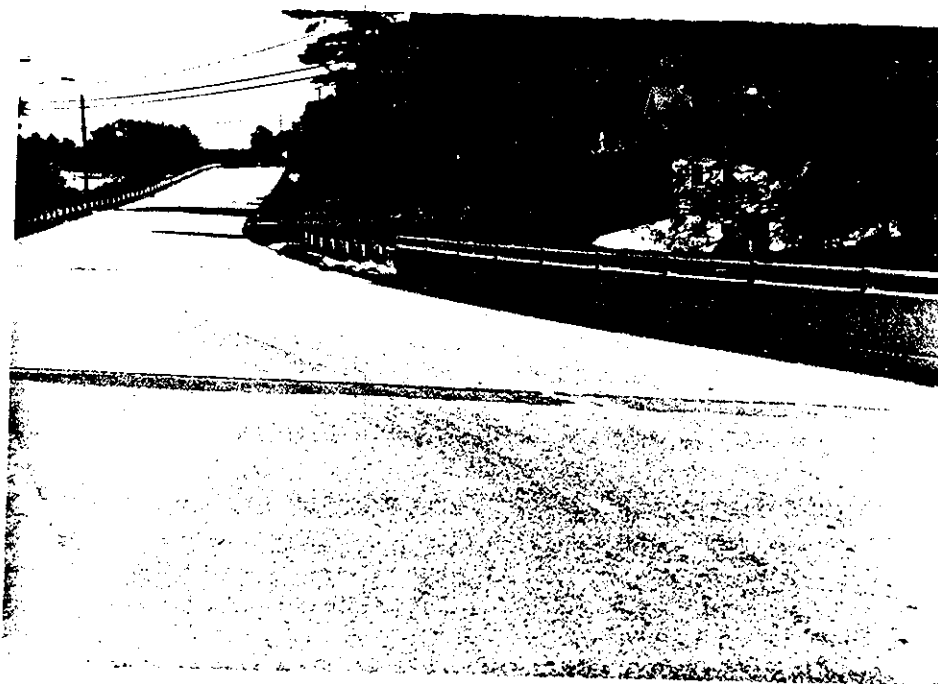
16. Bushnell Hill Road Bridge over the Little River
